Manhole Inspection Summary

Manhole # S43C2_011MH

Insp Date: **12/13/07 9:53 AM**

Location Address: **West Bay Ave.**

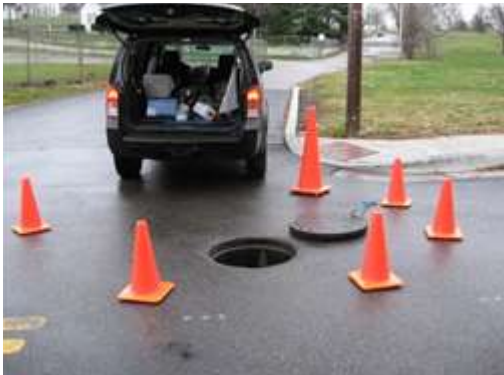
Location View

West Bay Ave.

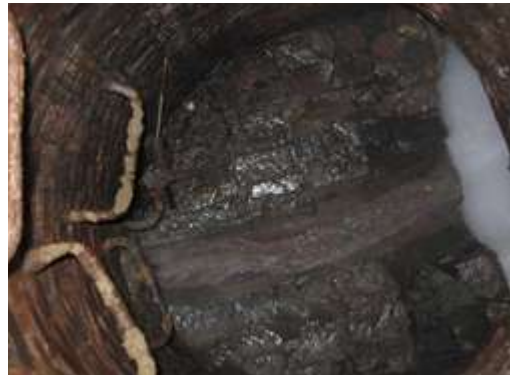
Top View

Comments **This is an offset manhole with the outflowing pipe in the top right corner. The main visible channel in the top view photo flows from 9 to 3 o'clock.**

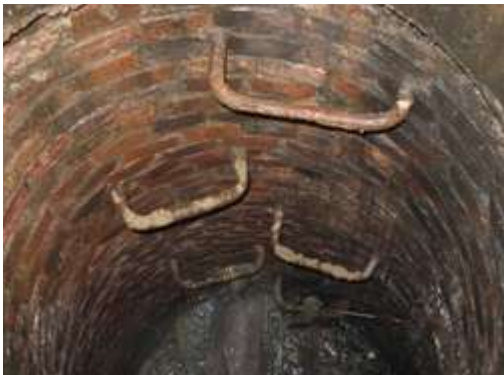
Steps

Count: **5** Missing: **0** ☐ Corroded

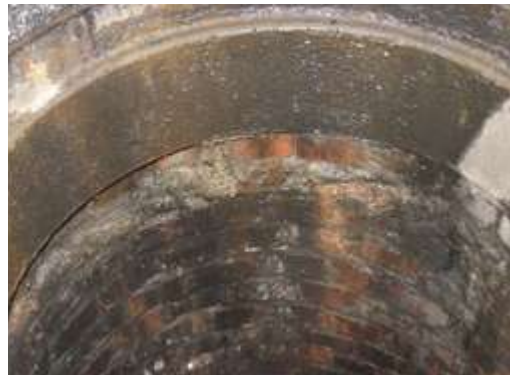
Defect 1

Infiltration: ☐ None ☐ Joint ☐ Cracks ☒ Mortar ☐ Roots ☐ Wall

Mortar

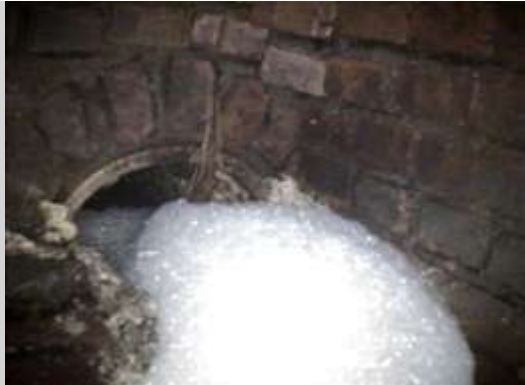
12 O'Clock Outflow

12 in. Circular Gravity Sewer
Pipe Out @ 12 O'Clock

Pipe Height: **16.8** (in.) Rod and Bar (Angled)
Pipe Material: **Clay** ☐ Pipe Lined
Invert Depth: **12.05** (ft.) Flow Characteristics: **Fast**
Deposits: ☒ None ☐ Mud ☐ Gravy ☐ Debris ☐ Grease
Silt Depth: (in.) Deposits Extent:
Infiltration: **None** Pipe Seal Cond: **Sound**

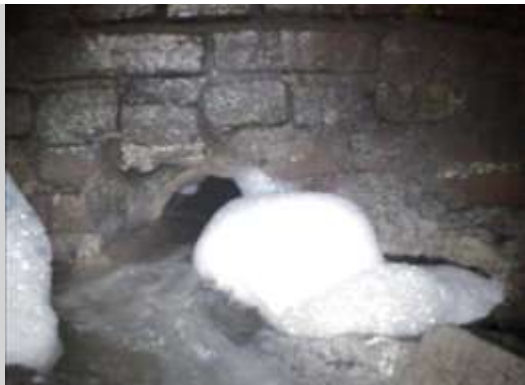
3 O'Clock Inflow

8 in. Circular Gravity Sewer
Pipe In @ 3 O'Clock

Pipe Height: **9.6** (in.) Rod and Bar (Angled)
Pipe Material: **Clay** ☐ Pipe Lined
Invert Depth: **11.86** (ft.) Flow Characteristics: **Fast**
Deposits: ☒ None ☐ Mud ☐ Gravy ☐ Debris ☐ Grease
Silt Depth: (in.) Deposits Extent:
Infiltration: **None** Pipe Seal Cond: **Sound**

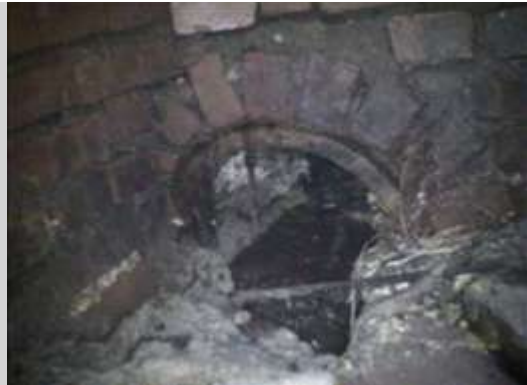
6 O'Clock Inflow

12 in. Circular Gravity Sewer

Pipe In @ 6 O'Clock

Deposits: ☐ None ☐ Mud ☒ **Sludge** ☐ **Debris** ☒ **Grease**

Silt Depth: **2** (in.) Deposits Extent: **Medium**

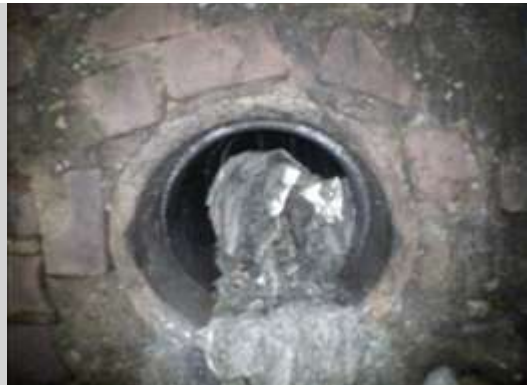
9 O'Clock Inflow

8 in. Circular Gravity Sewer

Pipe In @ 9 O'Clock

Deposits: ☐ None ☐ Mud ☐ Sludge ☒ **Debris** ☐ Grease

Silt Depth: **5** (in.) Deposits Extent: **Medium**

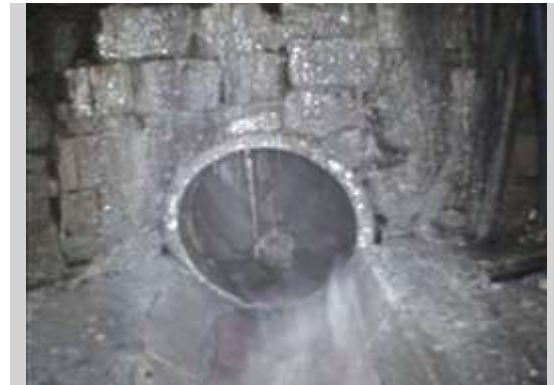
Drop In @ 9 O'Clock

Drop: **Outside** Rod and Bar
Angled: **Yes** Reading: **9.49** (ft.)
Inv Depth: **10.49** (ft.)

Drop Condition: **Open**
